DOT/FAA/AR-96/21

Composite Failure Analysis Handbook Update 1

August 1997

Final Report

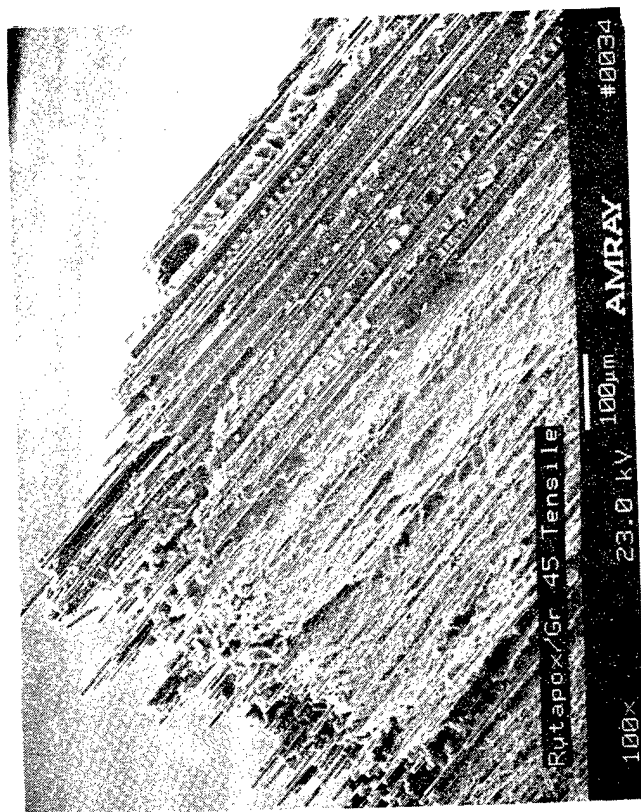
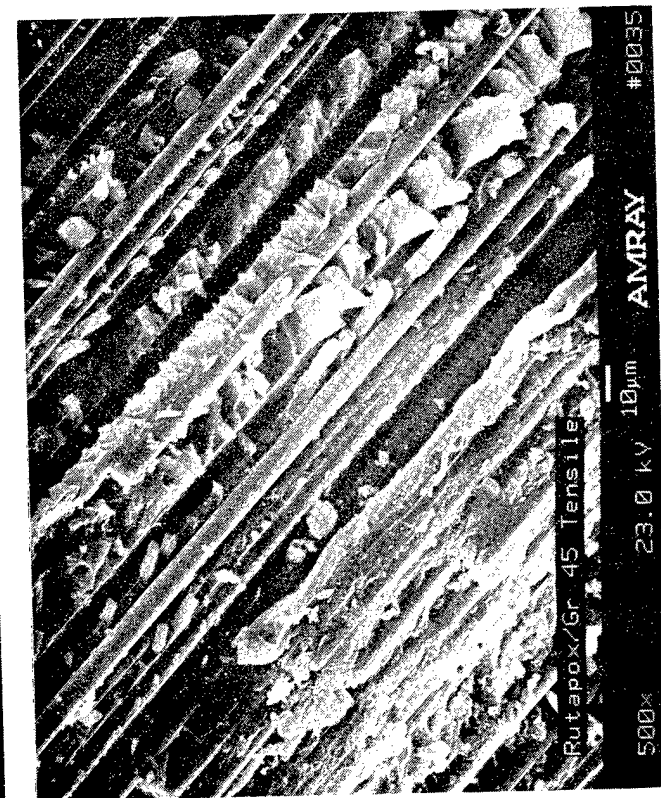
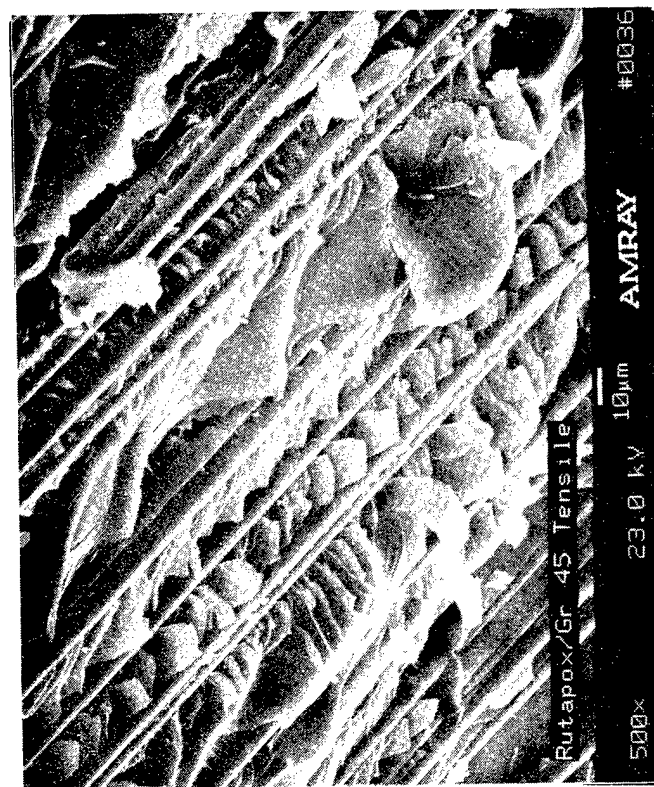
Figure 3.7-9. SEM Fractographs of a Rutapox/Graphite Fabric $\pm 45^\circ$ Tensile Fracture Surface, RT

The overall appearance of the fabric surface exhibited both mode I and II fractures features (Figure 3.7-9). The orientation of the hackles did not give an obvious indication of the overall crack propagation direction.

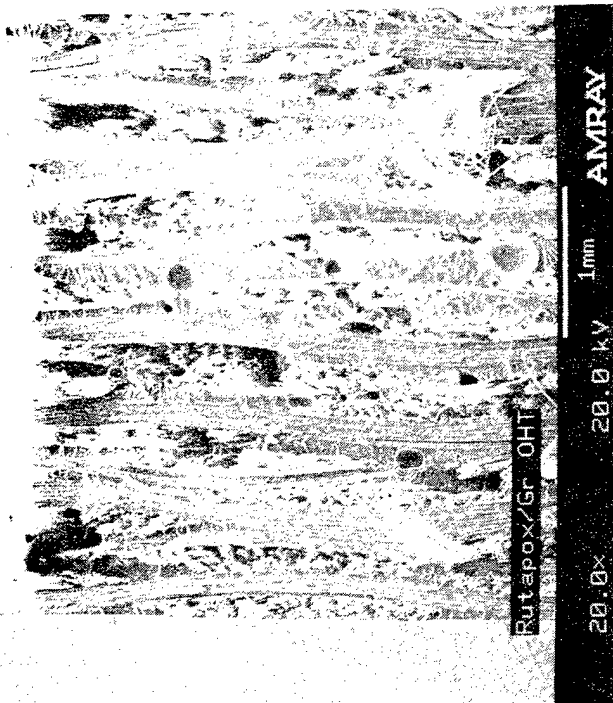
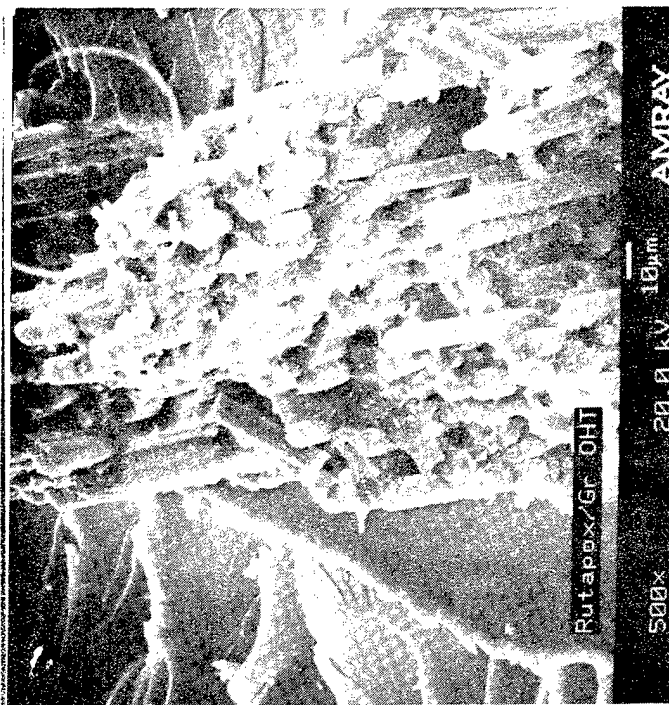
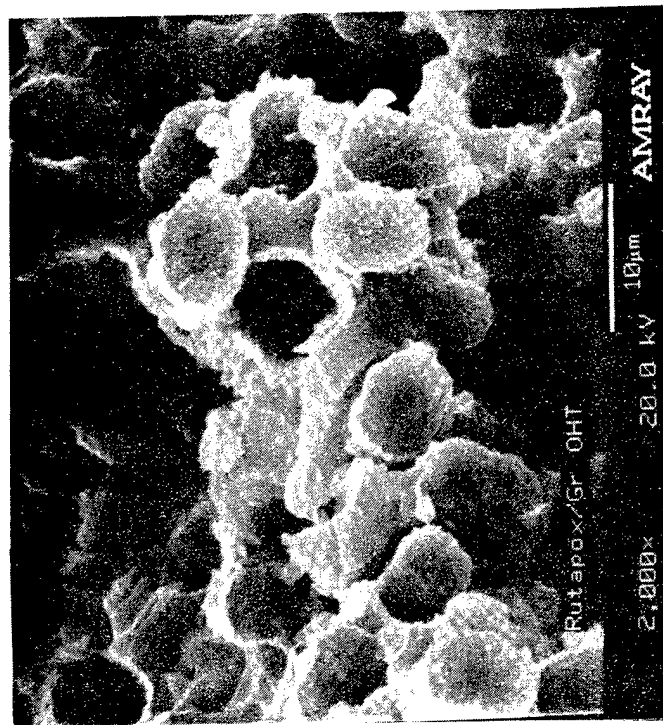
Figure 3.7-10. SEM Fractographs of a Rutapox/Graphite Fabric Open Hole Tension Fracture Surface, RT

The fiber ends did not clearly indicate the overall crack direction from examination of a small sample (Figure 3.7-10). The fibers were oval and contained distinct longitudinal ridges. Tracer yarns in the fabric were clearly visible and were initially confused with some type of fiber pull-out condition. The plies parallel to the crack direction had hackles on the surfaces, but it generally appeared that these tow regions were pulled apart in a mode I.

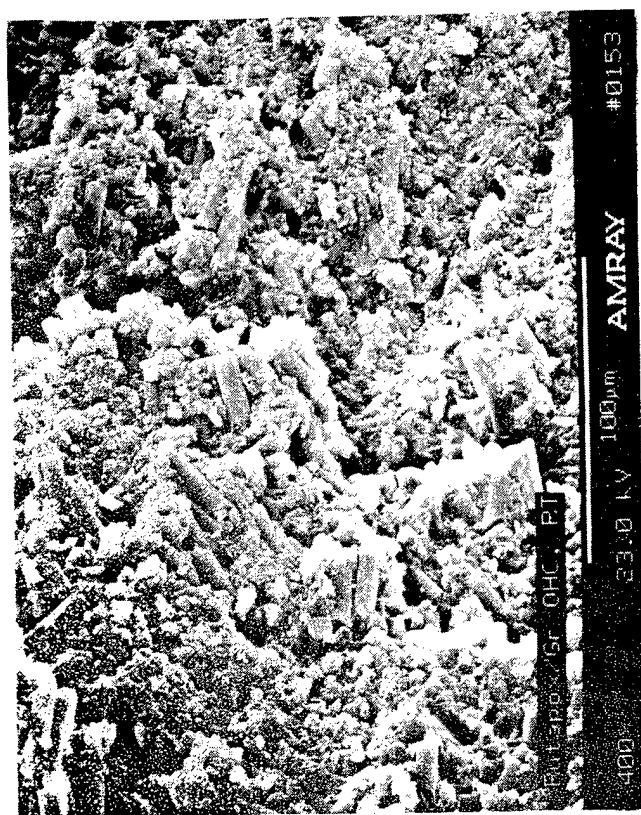
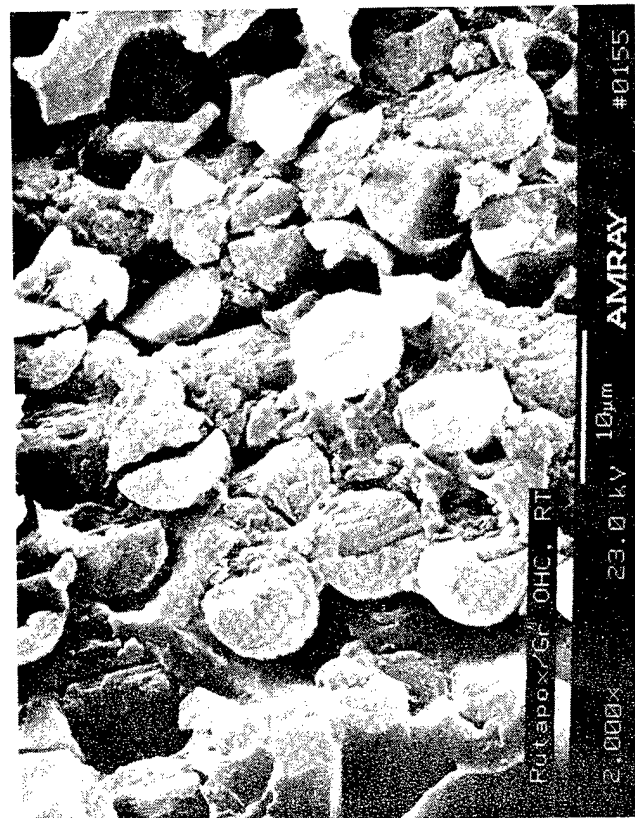
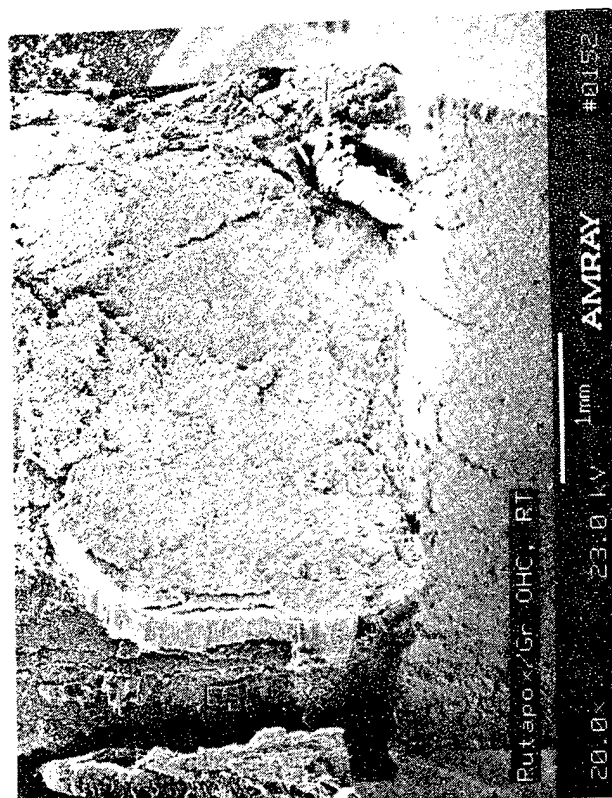
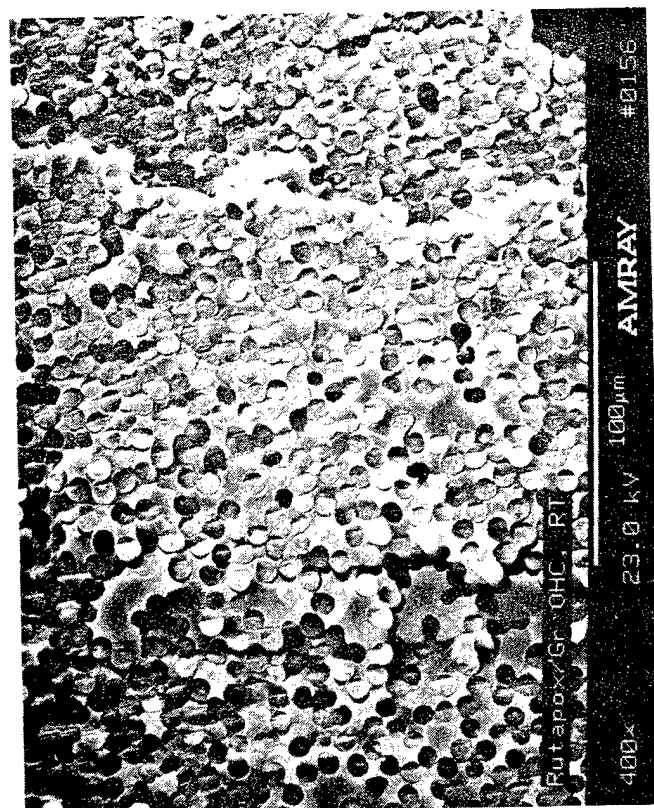
Figure 3.7-11. SEM Fractographs of a Rutapox/Graphite Rovings Open Hole Compression Fracture Surface, RT

Two distinct regions were present on the fracture surfaces (Figure 3.7-11). The region adjacent to the hole contained a great deal of rubble covered with small sections of fractured fibers. The regions further away from the hole exhibited the classic compression fracture morphology with the distinct centerline through the fibers. In addition, some of the fibers were actually split along their centerline to an unknown depth.

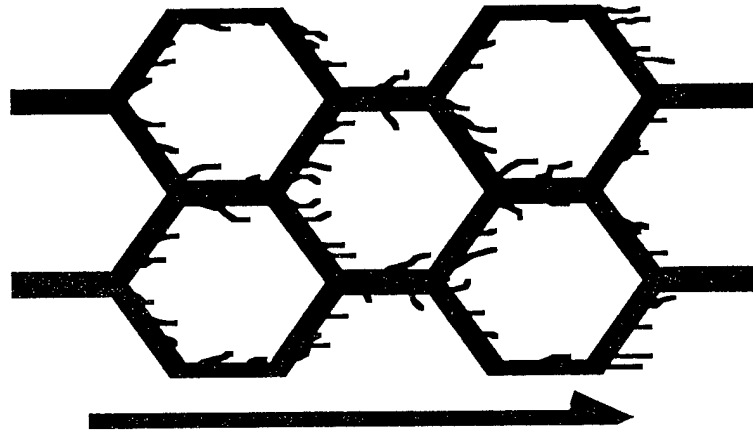
Figure 3.8-1. *Fibers Torn and Bent in the Direction of the Propagation of the Failure*

Failure propagation in honeycomb material is best determined by examination of the fiber pullout and by the direction in which the fiber is bent. As the honeycomb fails, the fiber and resin fail separately. The fiber is often freed from the resin by the failure and is drawn plastically in the direction of the displacement due to the propagation of the failure. For tensile failure this displacement is nearly normal to the direction of propagation, with a slight bias in the direction of propagation. The bias can result in plastic deformation of the side of the fiber away from the propagation direction or breakage of the fiber with the propagation direction of the crack in the fiber the same as that in the honeycomb. The result of these effects is that the propagation direction is indicated by the lay of the loose ends of fibers along the failed surface (see Figure 3.8-1). Studying the crack propagation directions in the resin meniscus where the honeycomb ribbons join is a more difficult method of determining the failure propagation direction.

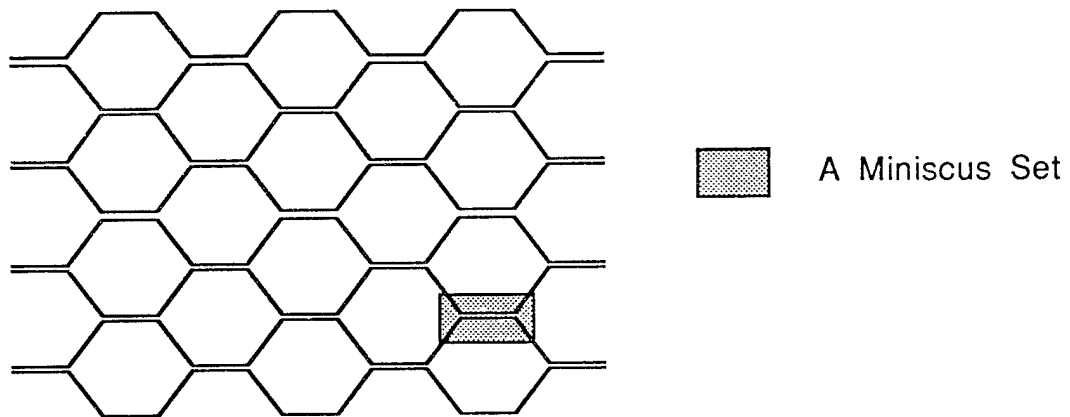
Figure 3.8-2. *Orientation of the Continuous Ribbons in the Honeycomb Denoting the Ribbon Direction and the Associated Meniscus Set*

The locations where the ribbons join have a double ribbon thickness and additional resin to strengthen that location (see Figure 3.8-2). The resin meniscus is a trilobate structure, with its weakest points at the terminations of these lobes or arms, which are directed 120 degrees from one another. In all the test specimens, the loading occurred such that propagation direction for the failure would be parallel to the ribbon direction. The failure could propagate only along one of three paths. Two of these paths were along single plies of ribbon oriented at 60 degrees from the line of the ribbon junctures. The other direction was that of the ribbon juncture (see Figure 3.8-3). Whenever one of these juncture areas failed, both menisci were involved. If the failure was the result of a traveling failure front, then one of the menisci broke from the juncture outward (the trailing meniscus) and one broke from one of the arms along the single-ply edge of the cell (see Figure 3.8-4). This meniscus set thereby indicates the propagation direction for that joint. The propagation direction for any one meniscus set may not be consistent with the overall direction of failure. The failure propagation

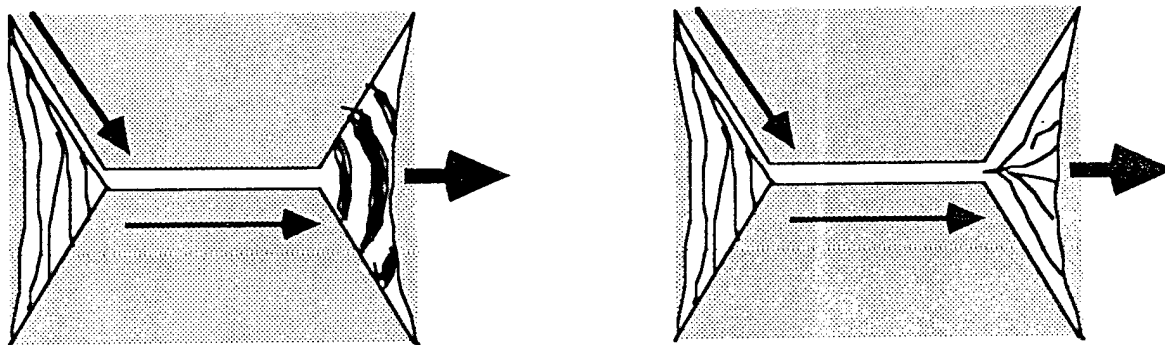
Figure 3.8-4. Failure Patterns in the Resin Menisci Indicating the Propagation Directions

The illustration on the left shows "Wallner" lines indicating the failure initiated at the apex of the upper arm of the meniscus. It then propagated across the joint and caused a conchoidal fracture in the trailing meniscus. The illustration on the right shows the same type of event but with a Wallner line failure pattern at the trailing meniscus.

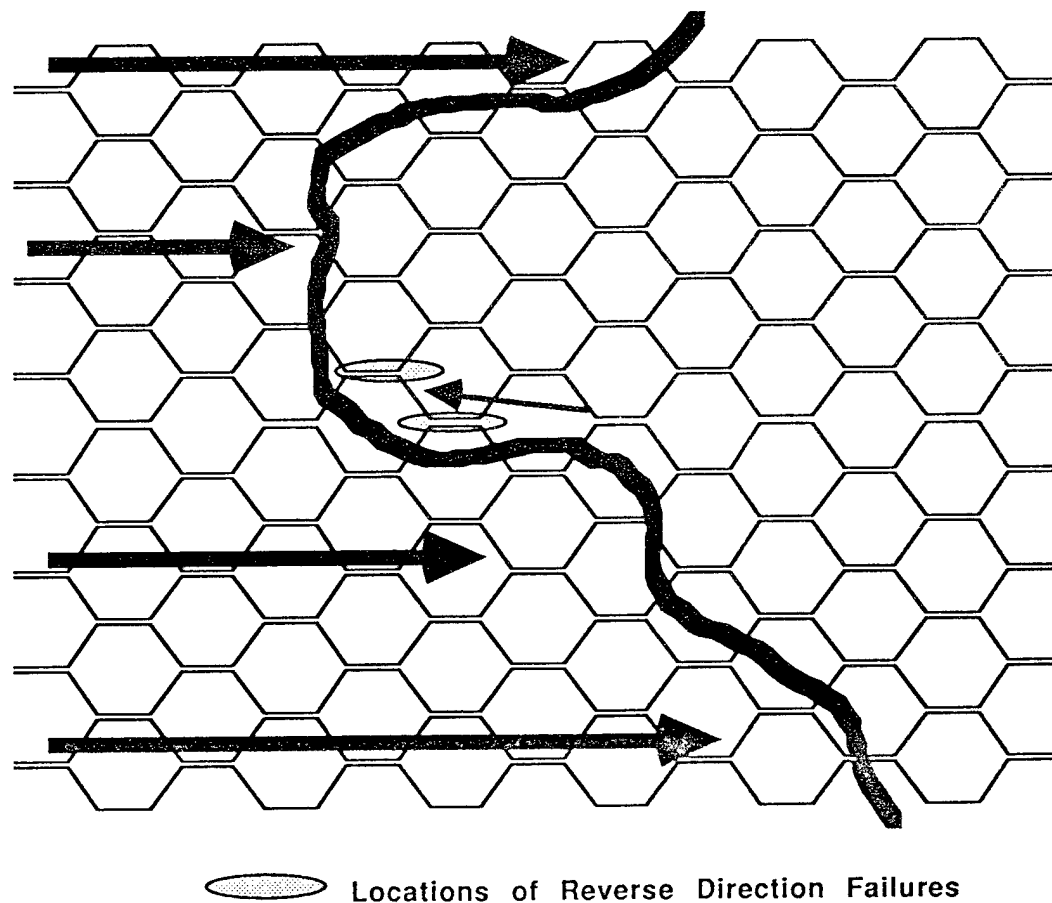
Figure 3.8-5. The Failure Front Doesn't Travel as a Straight Line and May, for Short Distances, Change Direction

front is not always a straight line (see Figure 3.8-5), which can result in local areas where the failure front may temporarily loop back on itself before jumping back to the main front. This would generate a meniscus pair with a failure propagation direction that was the reverse of the general propagation direction for the panel. Other possibilities include patterns that would indicate a direction of propagation at right angles to the ribbon direction (Figure 3.8-6) or vertical, with both menisci breaking in toward the center (Figure 3.8-7). As a result, the propagation direction on the scale of an individual honeycomb cell based on the meniscus resin failures would not reliably indicate the overall direction of the failure. Multiple sets of menisci would have to be examined to be confident in the overall direction of failure.

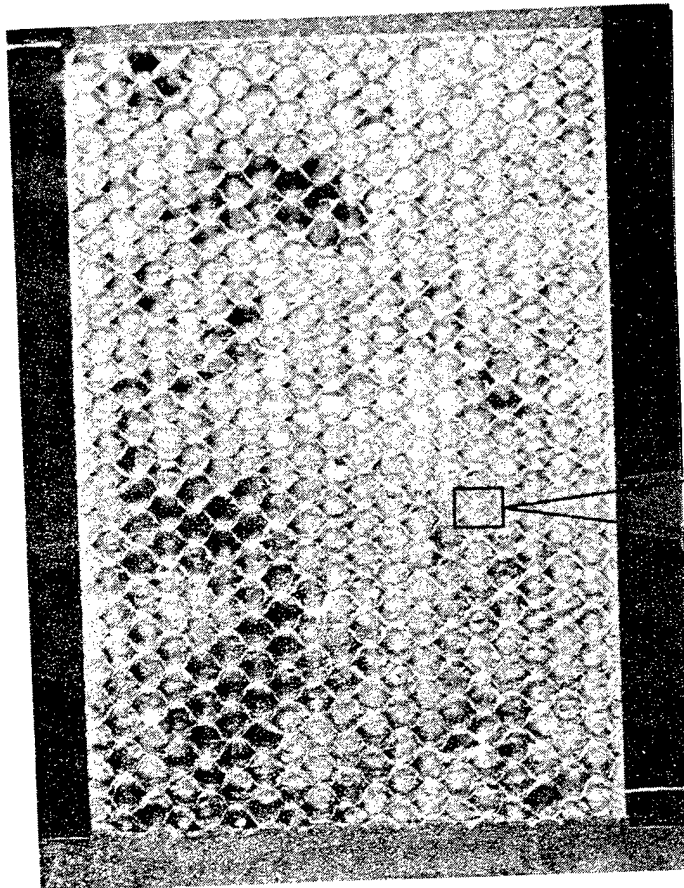
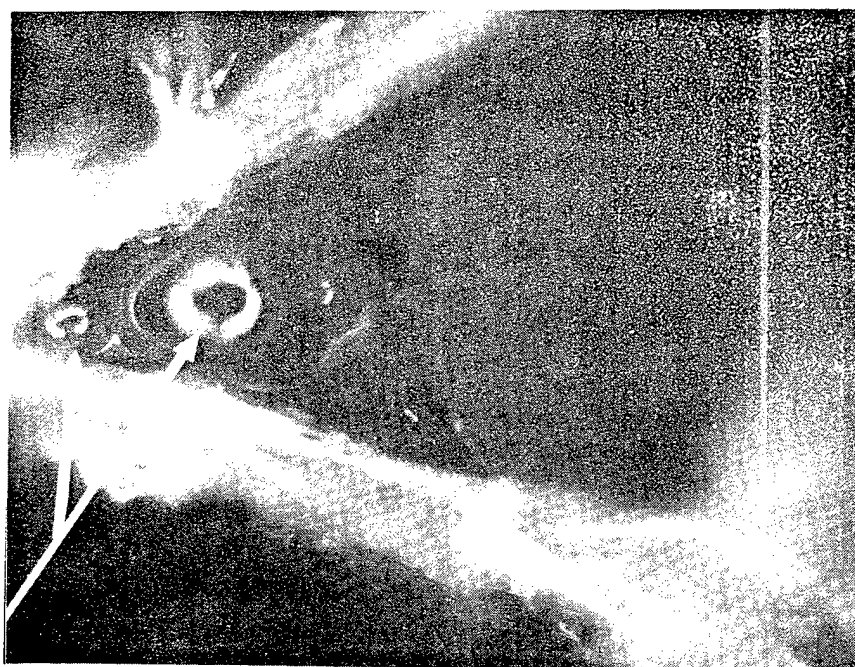
Figure 3.8-9. Optical Fractographs of Mode I Sandwich, Control Specimen
Sheet 1 of 2

Control Specimen. No adhesive or cohesive failures were seen in these specimen types. As shown in Figure 3.8-9, 100% core failure was observed.

Bubbles

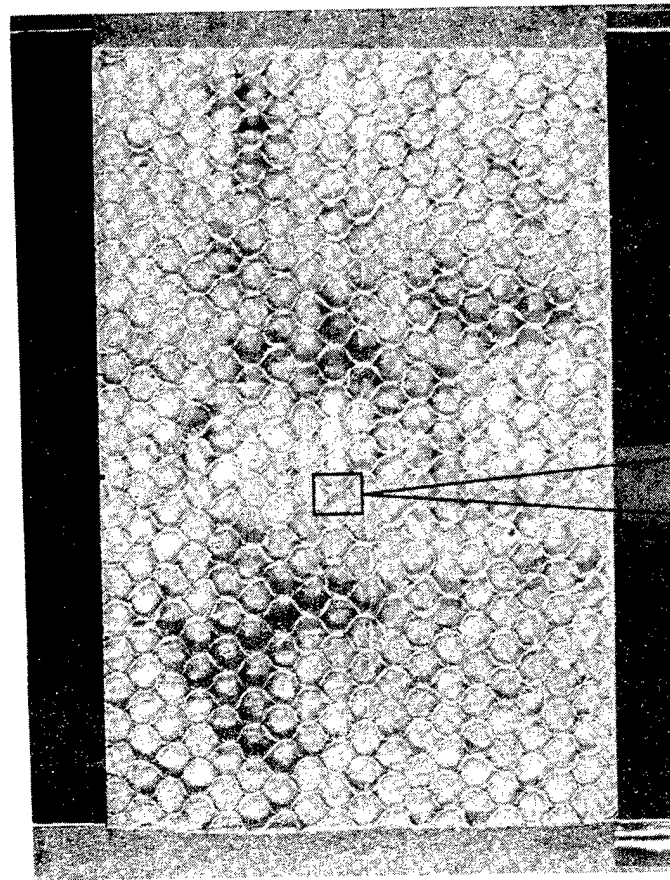
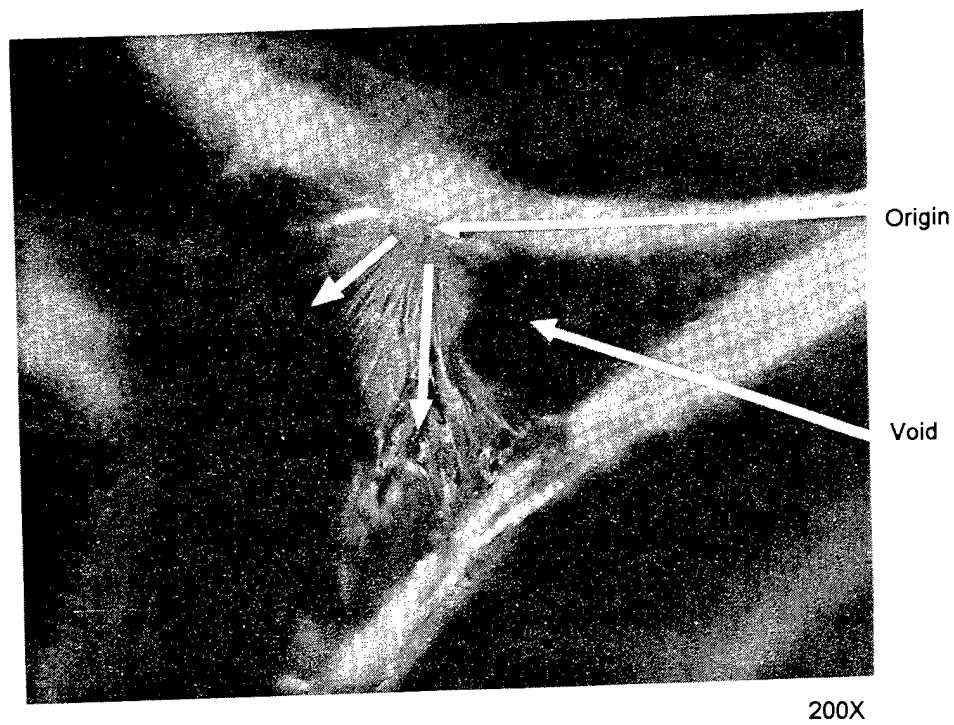
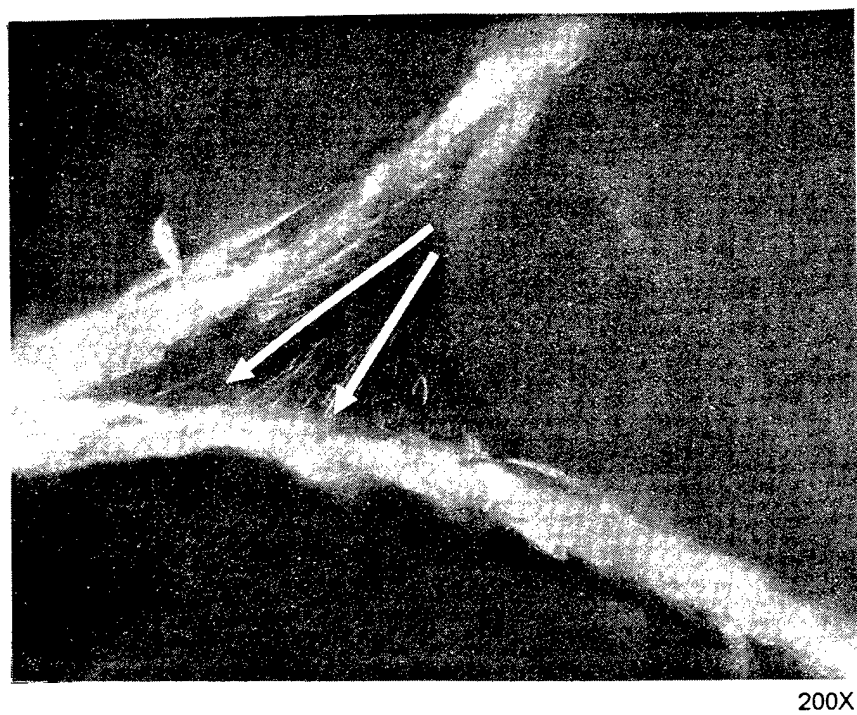
*Figure 3.8-10. Optical Fractographs of Mode I Sandwich, Aged Adhesive Specimen
Sheet 1 of 2*

Aged Adhesive Specimen. The honeycomb cells appeared to be more distorted in these specimens than in the others. It has not been determined if this is the result of processing or testing. The amount of burst fibers was less than that seen in the control specimen. As shown in Figure 3.8-10, the failure was in the honeycomb.

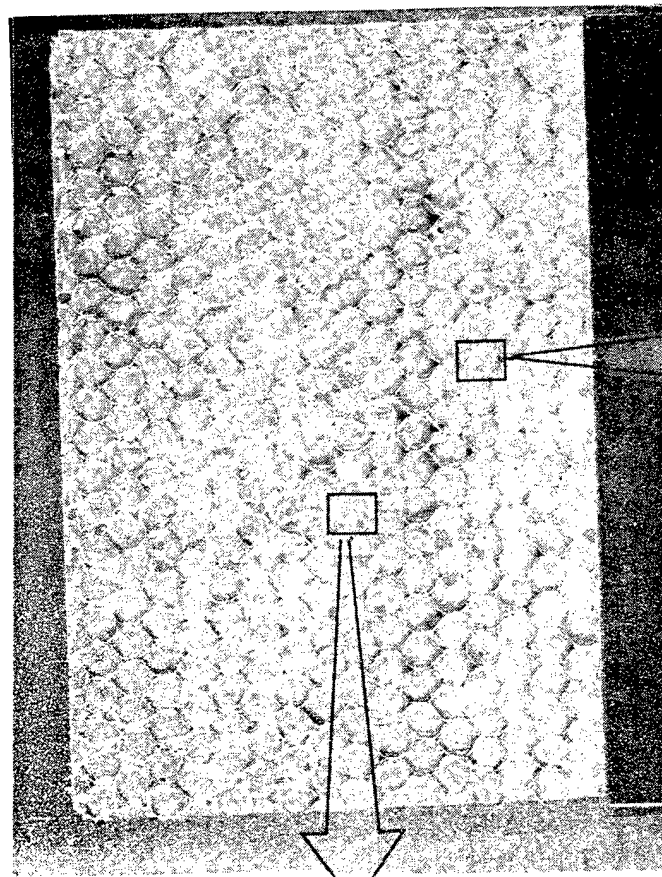
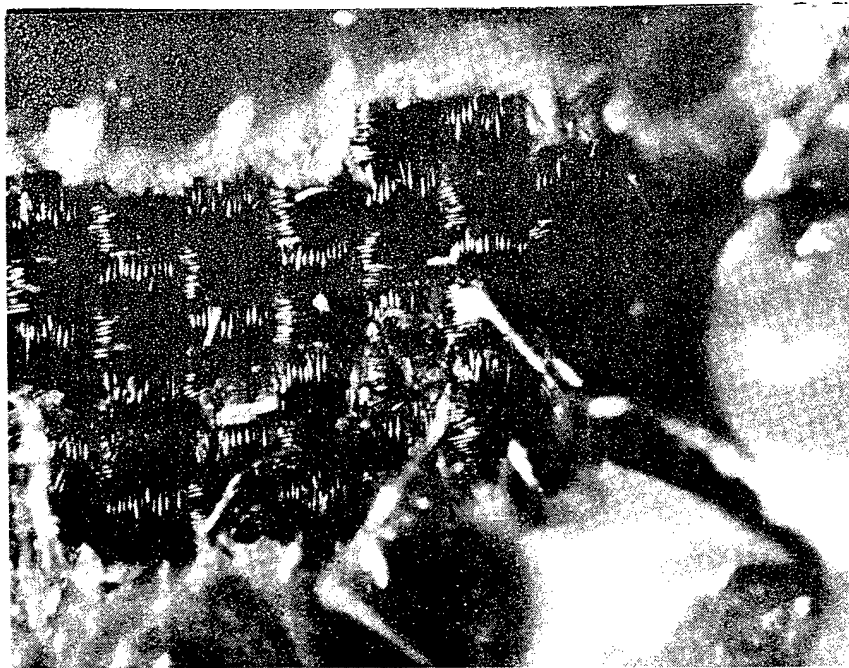
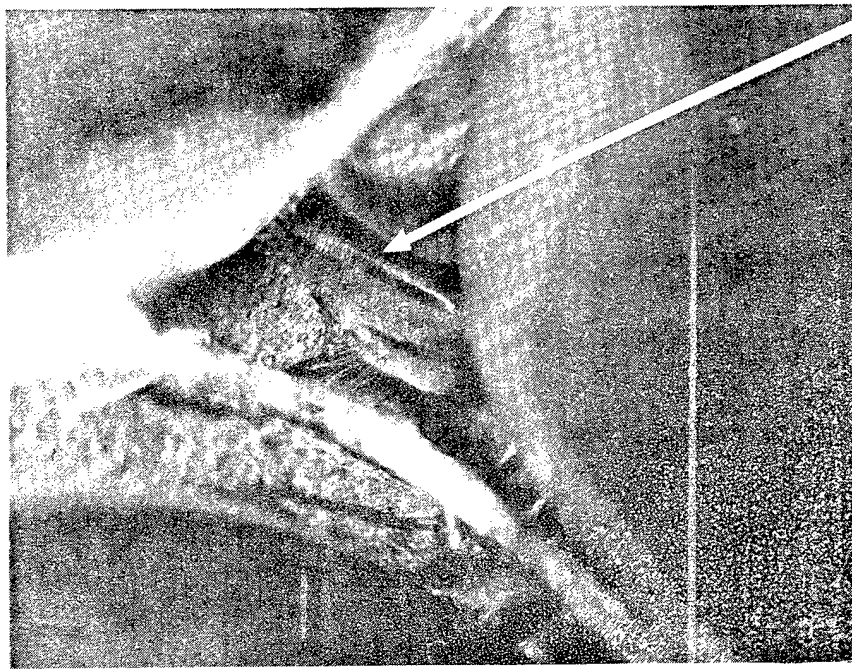
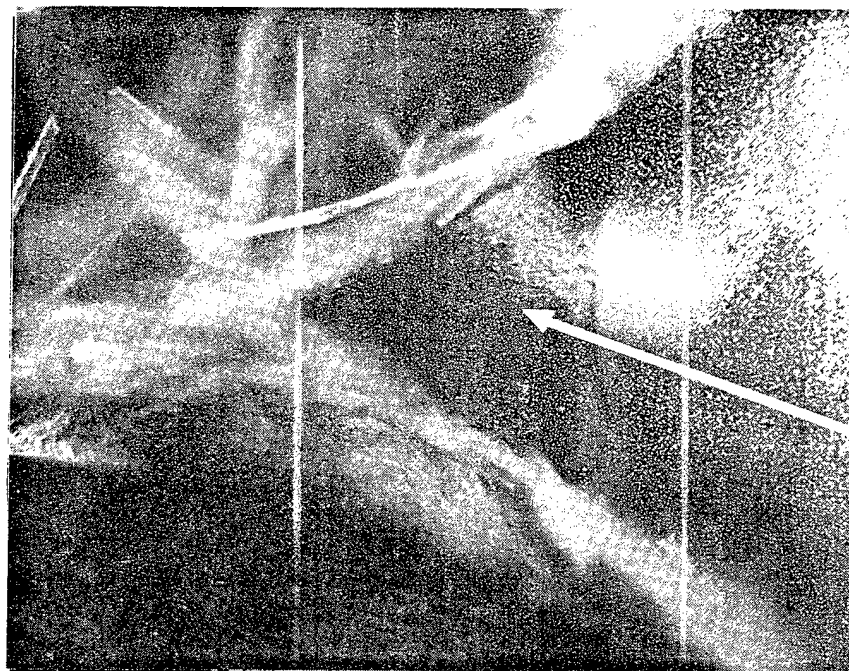
Figure 3.8-11. Optical Fractographs of Mode I Sandwich, Stronger Core Used (8-lb) Specimen
Sheet 1 of 2

Eight-Pound Core Specimen. The failure occurred primarily in the adhesive layer. Both adhesive and cohesive failure was evident. The adhesive failure, between the adhesive and the face sheet, occurred near the center of the specimen. Approximately 25% of the core failure was observed in these specimens. Optical fractographs taken at 200X showed a lower velocity fracture characteristic as evidenced by the mirror and mist fracture features shown in Figure 3.8-11.

Wallner
lines

Mist

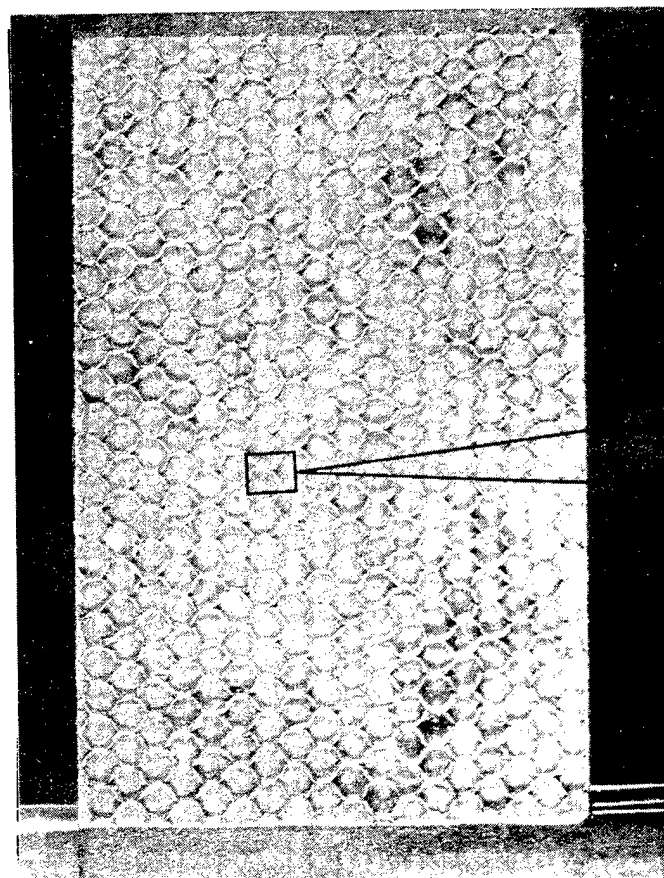
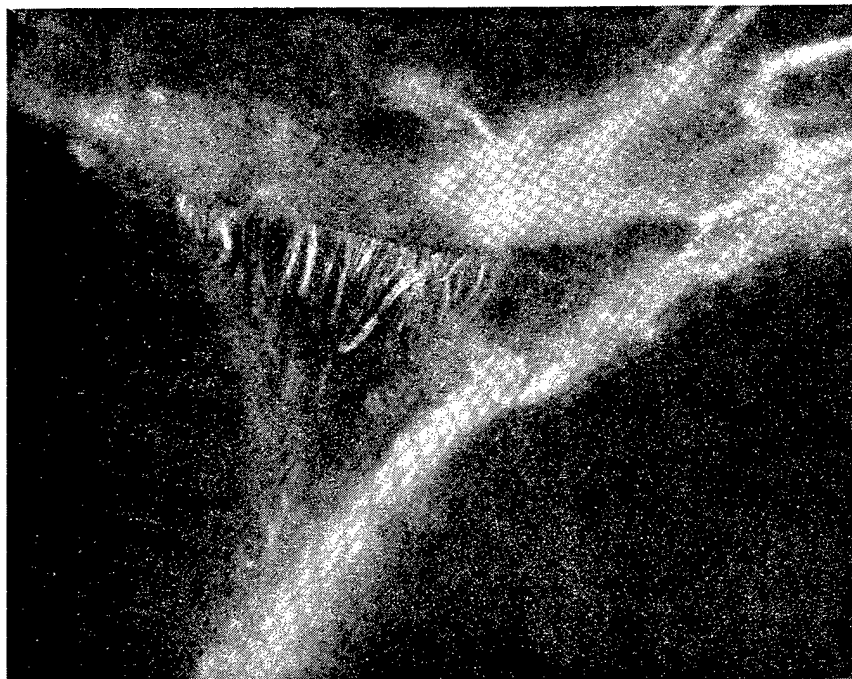
Figure 3.8-12. *Optical Fractographs of Mode I Sandwich Specimen, Undercured Adhesive*
Sheet 1 of 2

Undercured Adhesive Specimen. There was more burst fiber on the failure surface in this sample than in most of the others, except the control specimens, (Figure 3.8-12).

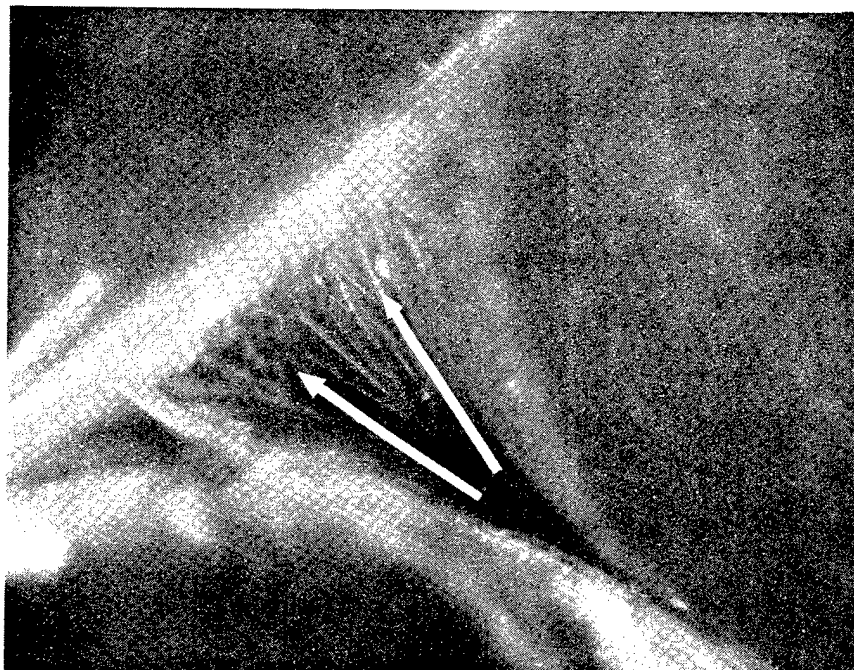
Sample 4B-2

Figure 3.8-12. Optical Fractographs of Mode I Sandwich Specimen, Undercured Adhesive
 Sheet 2 of 2

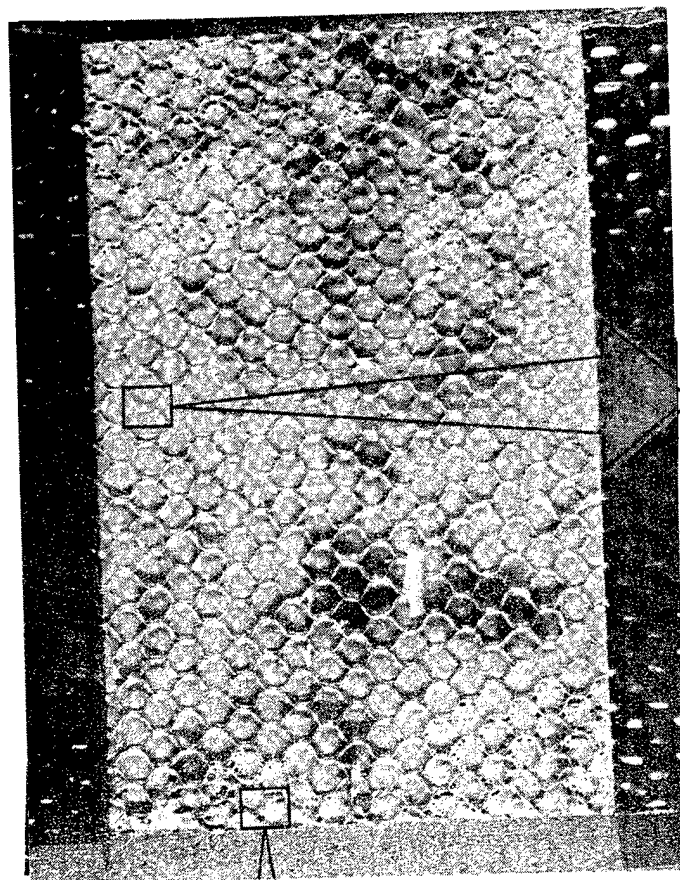
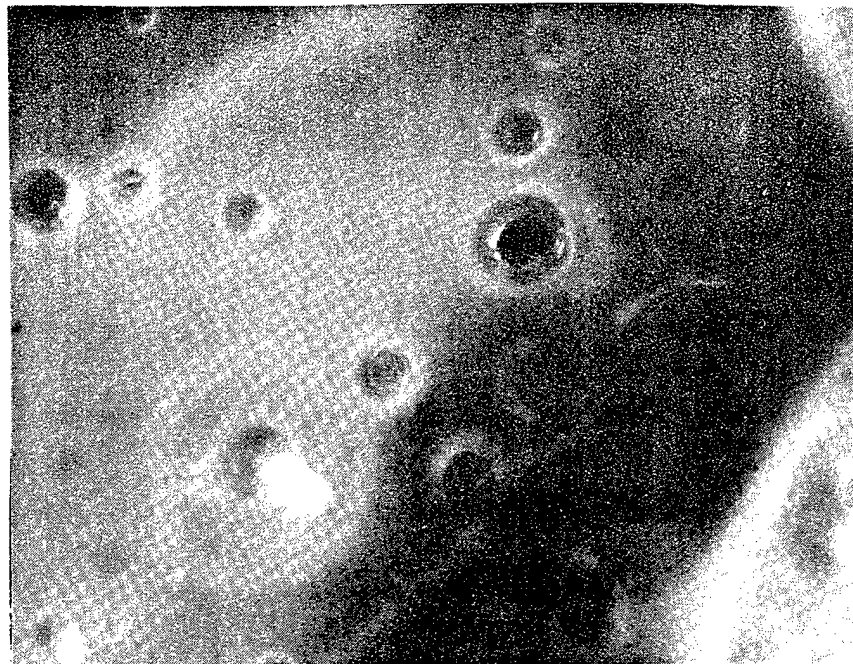
Sample 5A

Bubbles in adhesive layer

Figure 3.8-13. Optical Fractographs of Mode I Sandwich Specimen, Undercured Face Sheet Sheet 1 of 2

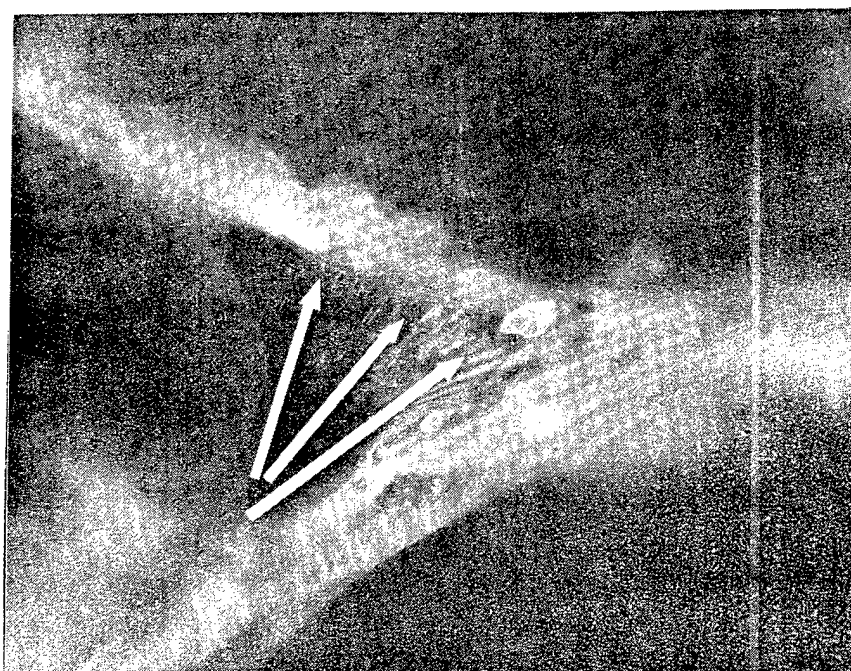
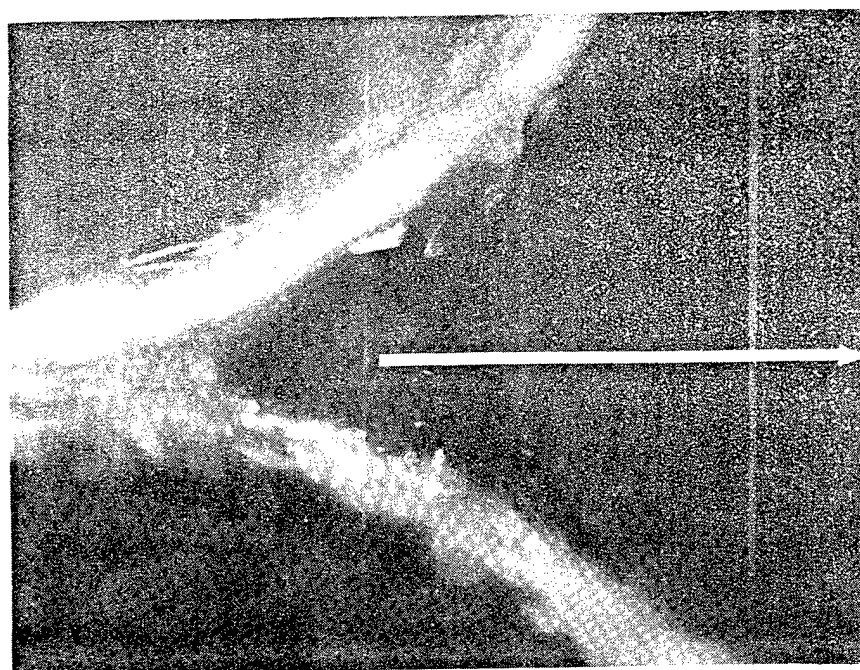
Sample 5A-1

Mirror

Figure 3.8-13. Optical Fractographs of Mode I Sandwich Specimen, Undercured Face Sheet
Sheet 2 of 2

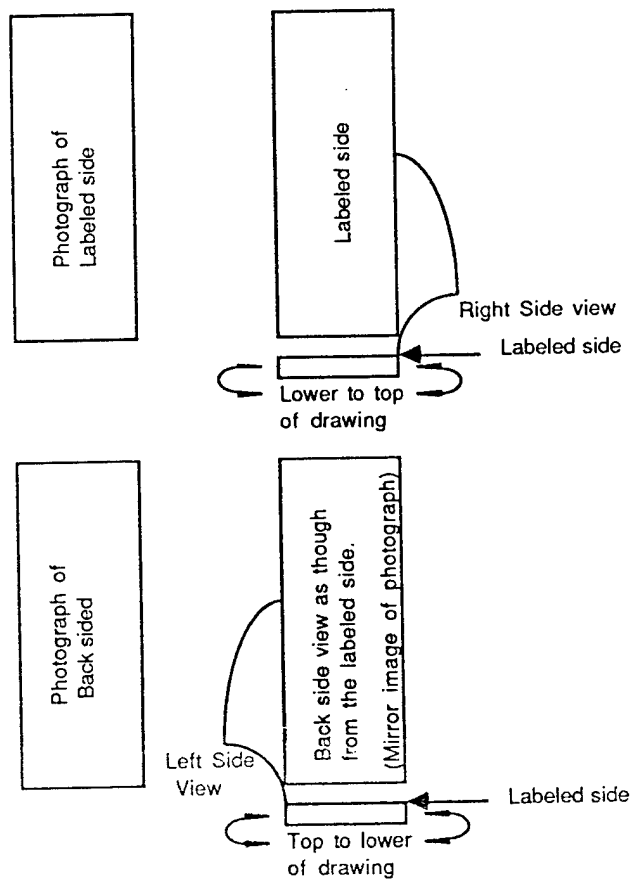
Samples were photographed as received, and surface failure pattern was documented graphically (see Figure 3.8-14). The pattern of the visible distortion on each of the sides related to the failure is schematically represented. The illustration of the labeled side of the panel is in the same orientation as the photograph of the panel. The edge illustrated just below the labeled side illustration is of the right edge with the labeled side of the panel on the top. The left end of the right-edge view is the lower section of the view, while the right side is higher along the edge. The illustration of the unlabeled side is drawn as though viewed from the labeled side to indicate the relative pattern of the failure on the two sides. The associated photograph is a mirror image of the illustration in this case. The left edge is illustrated below the illustration of the unlabeled side. The left end of the left-edge view is the higher section of the view, while the right side is lower along the edge.

Figure 3.8-14. Illustration of the Position of the Two Photographs and Four Drawings of Each Sample

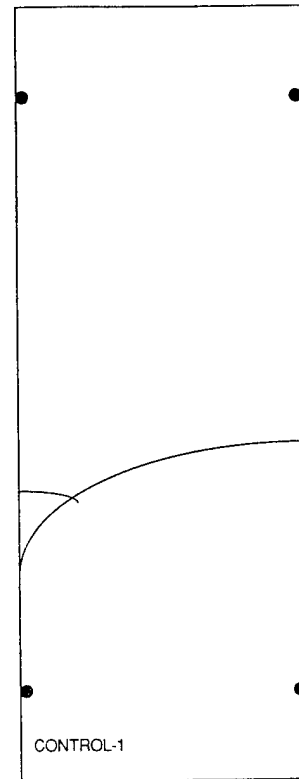
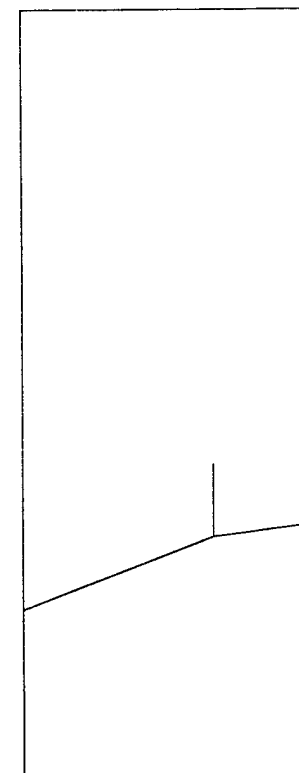
Figure 3.8-16. Control Sample 1—2.4X Reduction

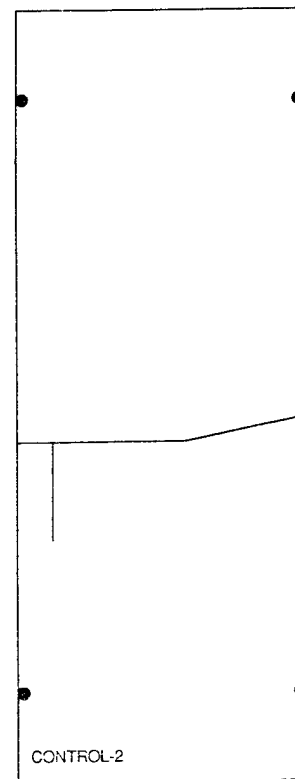
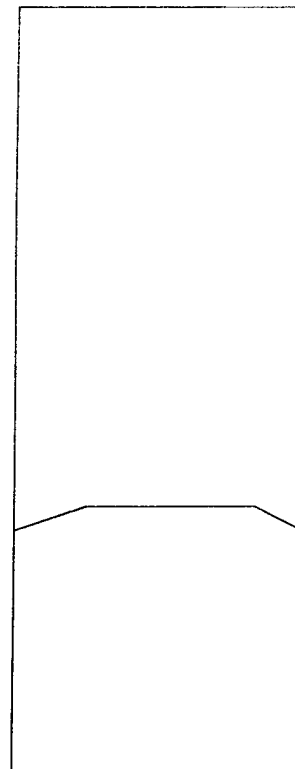
Figure 3.8-17. Control Sample 2—2.4X Reduction

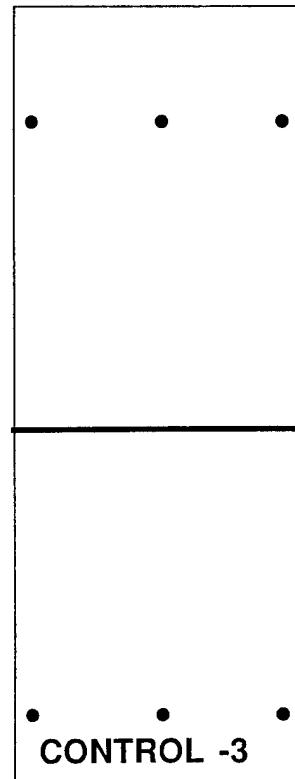
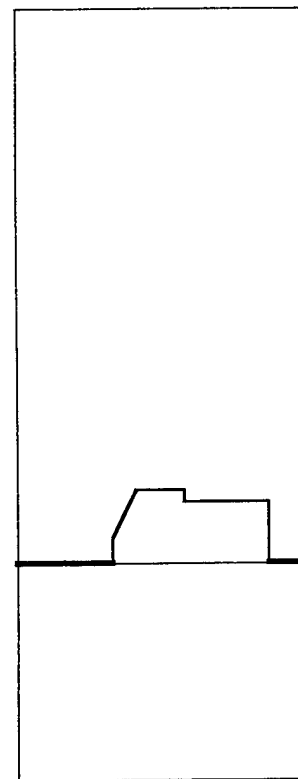
Figure 3.8-18. Control Sample 3—2.4X Reduction

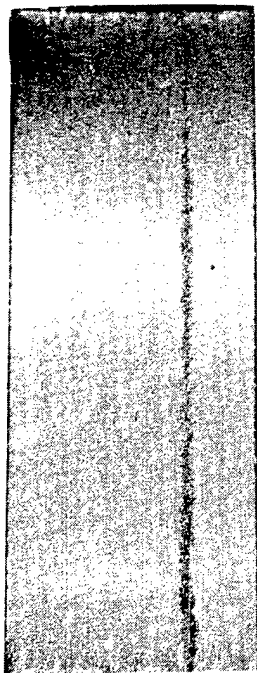
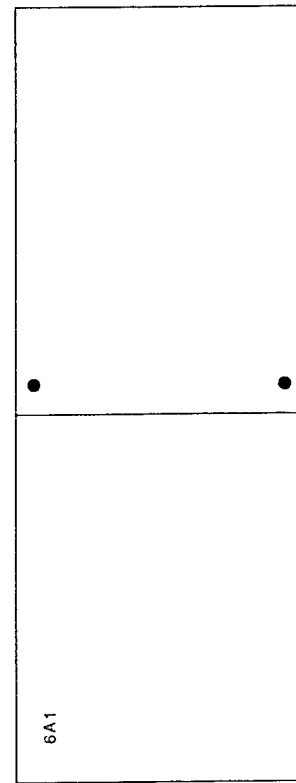
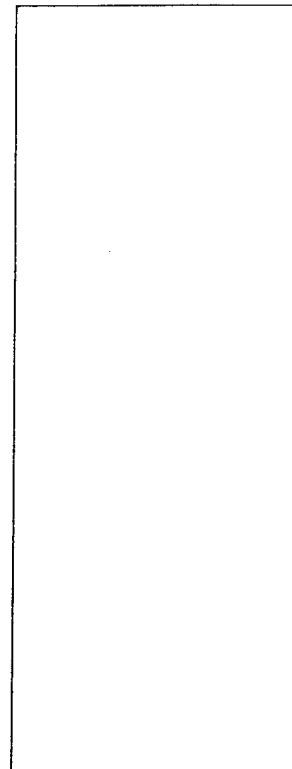
Figure 3.8-19. Aged Adhesive Sample 6A1—2.4X Reduction

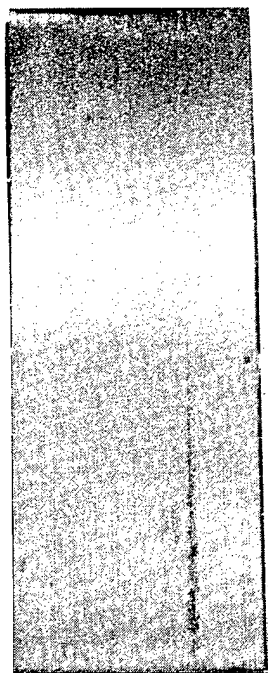
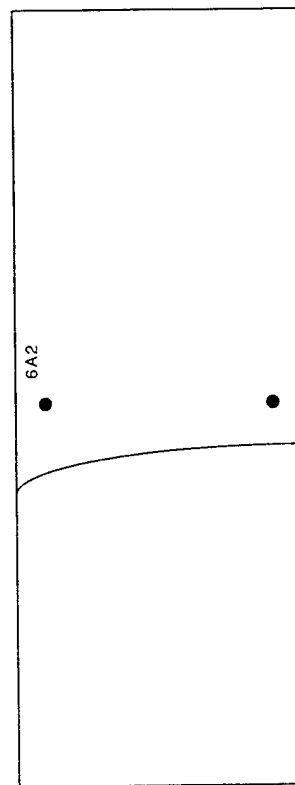
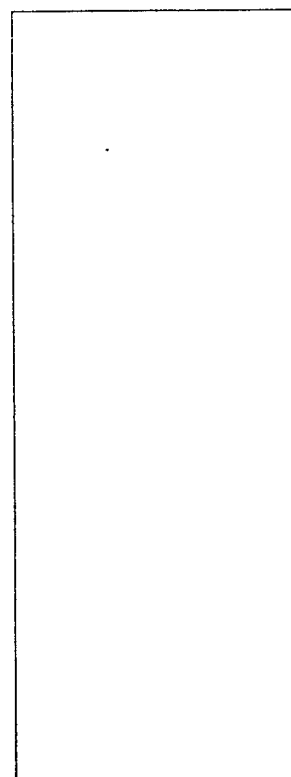
Figure 3.8-20. Aged Adhesive Sample 6A2—2.4X Reduction

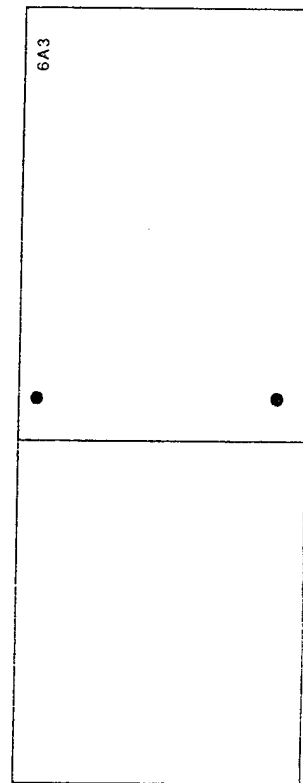
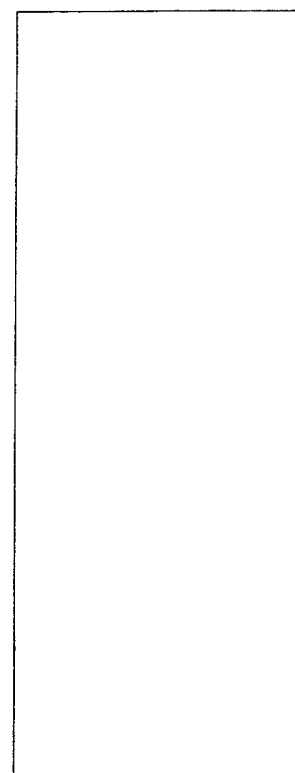
Figure 3.8-21. Aged Adhesive Sample 6A3—2.4X Reduction

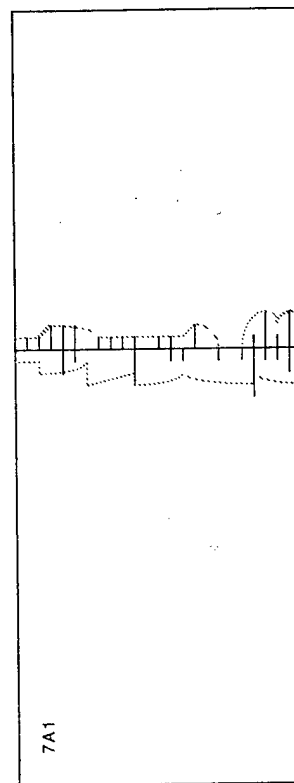
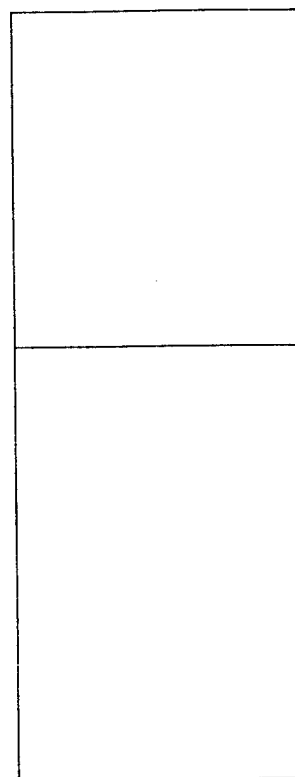
Figure 3.8-22. Improper Core Sample 7A1—2.4X Reduction
